NASA Technical Memorandum 86306

**INVESTIGATING COMPRESSION FAILURE MECHANISMS IN
COMPOSITE LAMINATES WITH A TRANSPARENT FIBERGLASS-EPOXY
BIREFRINGENT MATERIAL**

MARK J. SHUART AND JERRY G. WILLIAMS

AUGUST 1984

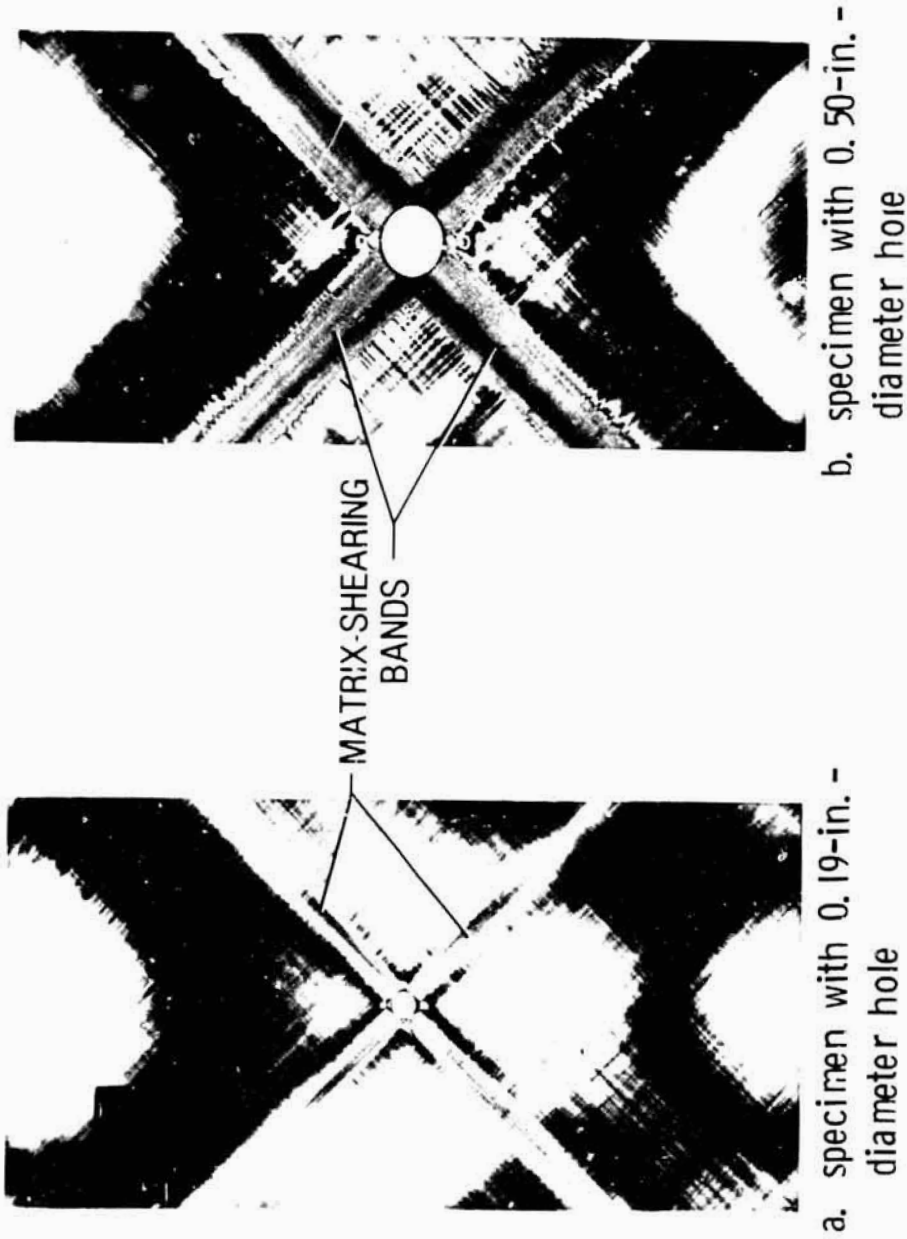
NASA
L-84-5476

Experimental results presented in figures 2 and 3 illustrate the value of the birefringent material for observing failure of composite specimens. The specimens shown in figure 2 were loaded and then unloaded. When these unloaded specimens are illuminated with polarized light, the isochromatic fringe patterns on the specimens indicate that plastic deformation has occurred. The pattern on the specimen in figure 2a indicates that high stresses exist in bands oriented at $\pm 45^\circ$ to the load axis. Using the transformation of stresses for this

uniaxially loaded laminate, the inplane shear stress τ_{12} is a maximum on elements oriented 45° to the applied load which results in high stresses in the epoxy matrix between fibers. The high stresses in the bands in figure 2a are caused by inplane fiber-matrix shearing in these regions and are identified as matrix-shearing bands in the figure. While the specimen was being loaded, these bands initiated at the hole boundary and grew toward the specimen edges. The specimen shown in figure 2b was loaded further into the plastic range than the specimen shown in figure 2a. This specimen also has matrix-shearing bands, but the isochromatic fringes are not observed in the region of these bands. While the specimen was being loaded, severe internal damage occurred within the bands which disrupted the light path and destroyed the birefringency property. The damage was caused by local delamination and inplane shearing failure mechanisms. When this specimen was illuminated with white light (fig. 3), the damage in the matrix-shearing bands is indicated by the $\pm 45^\circ$ dark bands. The damage is most severe at the two locations where the hole boundary intersects the horizontal centerline of the specimen, the locations where damage initiated. Closer inspection of the damaged regions reveals a fiber-kinking mechanism that occurs at the boundaries of the matrix-shearing bands. A sketch illustrating this fiber-kinking mechanism in the hole-boundary region is shown in figure 3. The kinking results from a $+45^\circ$ layer partially restraining the inplane shearing occurring in an adjacent -45° layer or vice versa. The fiber kinking occurs without fiber breakage due to the flexibility in the matrix provided by extensive shear failures.

Figure 2. Fiberglass epoxy birefringent specimens after being loaded beyond the elastic limit. Both specimens are illuminated with polarized light.

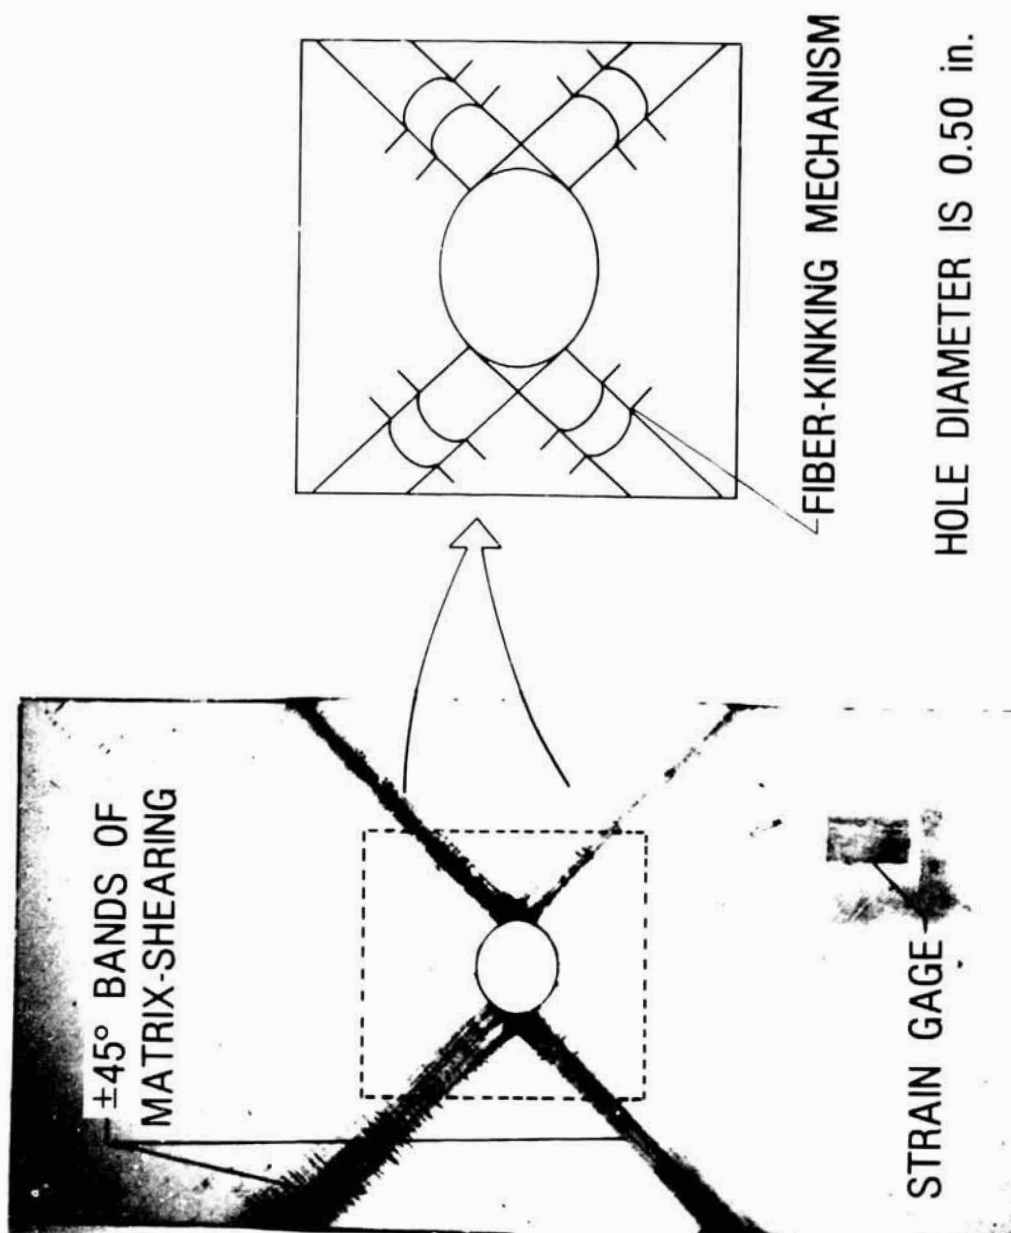
Figure 3. Failed fiberglass-epoxy specimen illuminated with white light.
